MARINE ACCIDENT INVESTIGATION BRANCH

FLYER TO THE SHIPPING INDUSTRY Entering Dangerous Enclosed/Confined Spaces

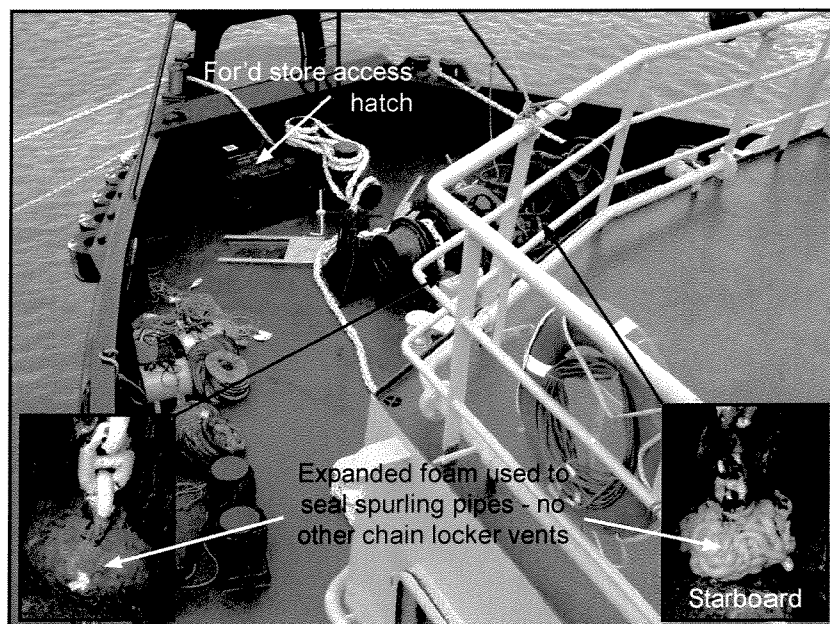
While attempting to secure a rattling anchor chain within the chain locker, one seaman collapsed. The supervisor raised the alarm and then entered the chain locker to rescue his shipmate; he too collapsed. Both men died as a result of the oxygen deficient atmosphere inside the chain locker; this was due to the natural on-going corrosion of the steel structure and anchor chain.

A simple inspection, taking only a few minutes, would have shown that this chain locker was effectively a tank, made air tight by expanding foam used to seal the spurling pipes. Even without the expanding foam this chain locker was a potentially dangerous enclosed/confined space, and a formal safe entry procedure should have been followed.

- That company policy regarding the requirement to enter dangerous enclosed/confined spaces on board their ships is clear, and that the equipment provided on board is adequate for safe entry.
- That crew training and drills for entering dangerous enclosed/confined spaces are as realistic as possible, always considering the overriding requirements of safety during such drills.
- That EEBD training is sufficiently realistic to ensure that the full extent of the limitations of this type of equipment is revealed to all potential users.

- That they are able to recognise a dangerous enclosed/confined space, and are aware that in such spaces, the atmosphere could become lethal during routine shipboard operations. In order to enter such spaces, the MCA Code of Safe Working Practices and their company Safety Management System must first be consulted, and all due precautions taken.
- That they are fully aware of the purpose and limitations of the EEBDs carried on board their ship, and when it is necessary and appropriate to use these devices.
