Marine Safety Forum – Safety Flash 11-01

Issued: 5th January 2011

Subject: Eye Injury – Compressed Air Line

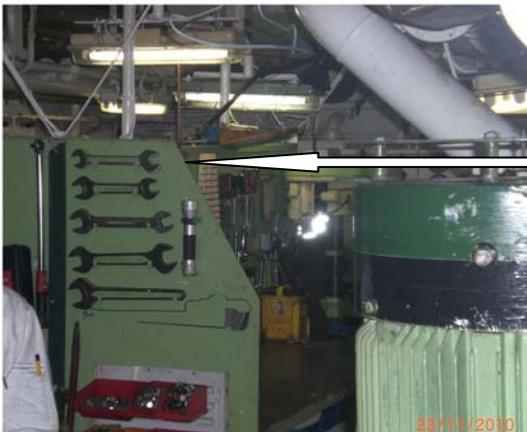
Position of the doorway between
Cement room and Engine room.

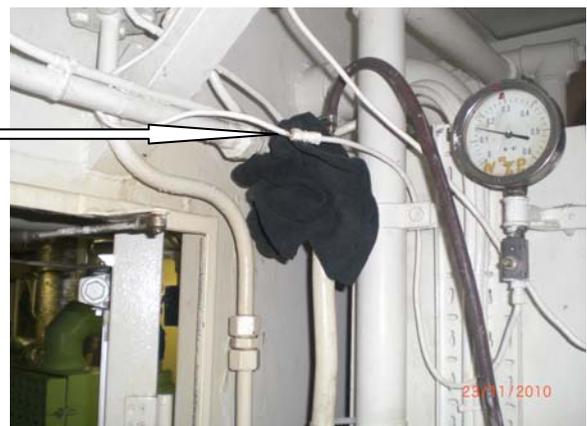
Location of removed vertical pipe.

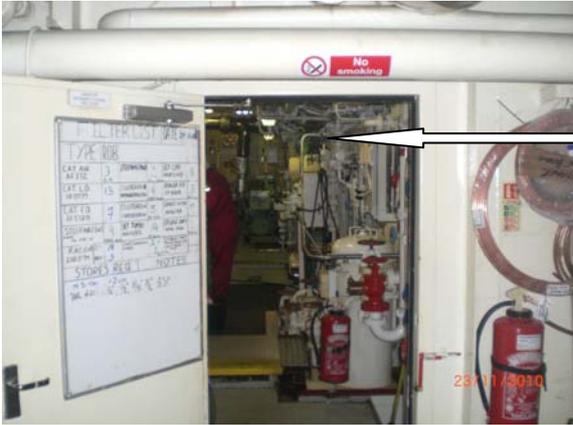
The view the IP had as he walked through the Cement room / Engine room doorway. (The detached vertical pipe is located through the doorway and immediately to the left)

The Engineer then opened the valve slightly to allow the air to flow through the pipe work, at exactly the same time the IP walked through the doorway from the Cement room to the Engine room as the blockage was expelled, pushing off the tie wrapped rag where some of the spray and debris hit him on the left side of the forehead. The residue of the Anti-Foulant chemical which was blown out, ran down the IP's face and entered his left eye. The IP was treated with several Saline eye washes, whilst arrangements were made for his transfer ashore to have his eye checked by a Specialist.

- A Permit to Work had not been opened by the Engineer to control the Use of Compressed Air and Use of Chemicals.
- As the Engineer could not see either the location of the removed pipe or anybody approaching the doorway adjacent to it due to the 2 workbenches, it was found that this job should have been deemed a 2 man job rather than a 1 person job.
- The Risk Assessment did not include the use of barriers or tape.
