# Marine Safety Forum – Safety Flash 13-09

Issued: 4<sup>th</sup> March 2013

## Subject: Gangway Safety

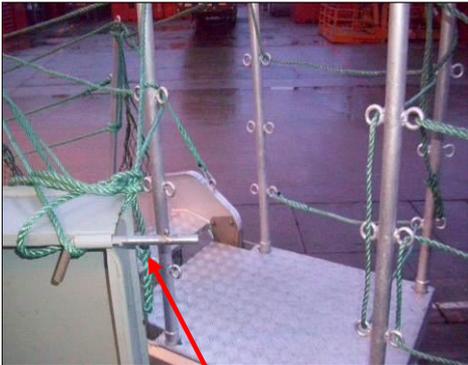
1. A stevedore was injured when his leg made contact with a protruding securing pin.

*Securing pin for bulwark door protruding from its socket*

6. Where necessary a bulwark ladder must be provided, safety fenced to a minimum height of 1m.
7. Guard ropes must be kept taut at all times and stanchions must be rigidly secured.

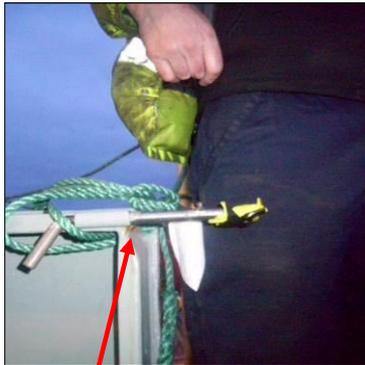
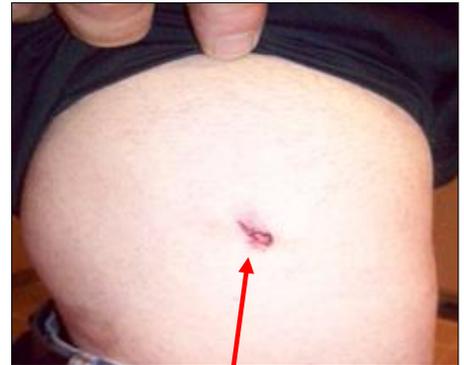
*Puncture wound to stevedores leg*

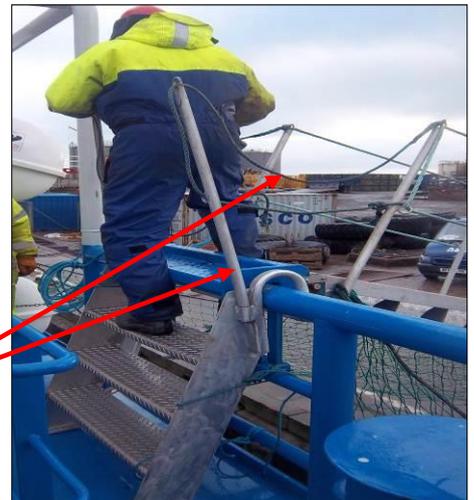
2. A poorly positioned and designed bulwark ladder led to a stevedore slipping and falling due to the excessively steep angle. The design of the ship does not help due to the limited deck space at the top of the gangway. The incident was made worse by the presence of slack guard ropes, resulting in the stevedore having nothing to grab on to as he fell.

*Note the excessively steep bulwark ladder and also the slack guard ropes and loose stanchions*

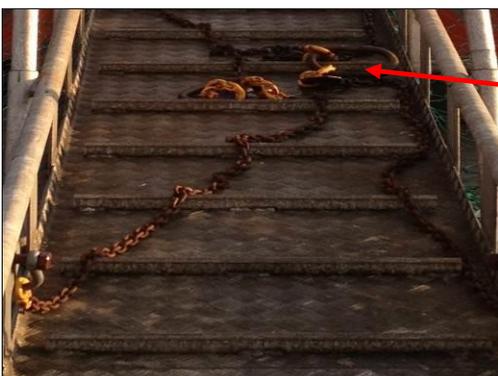
3. Recently sighted bad practice has included obstructions on the gangway in the shape of carelessly placed lifting bridles and lifting strops left hanging over guard ropes, reducing their effective height.

*Potential trip hazard from lifting bridle*

8. The gangway must be kept clear of cargo operations and quayside obstructions.
9. The gangway must be kept clear of any materials, substances or obstructions likely to cause a person to slip or trip.

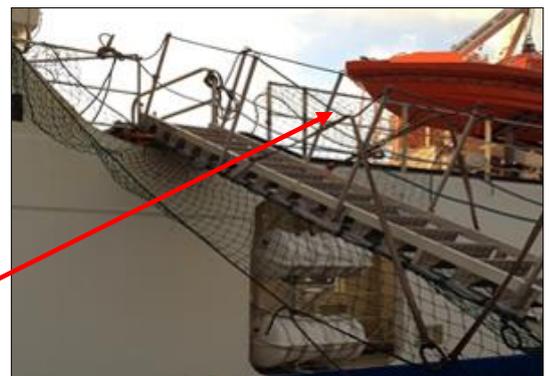
*Lifting bridle left hanging over the guard ropes*

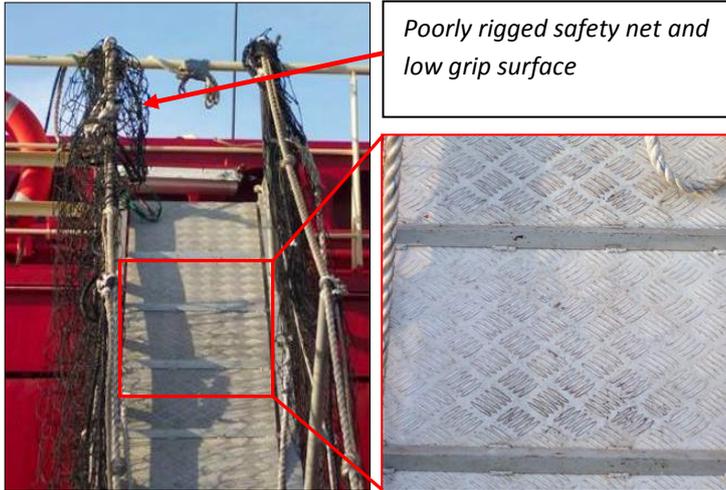
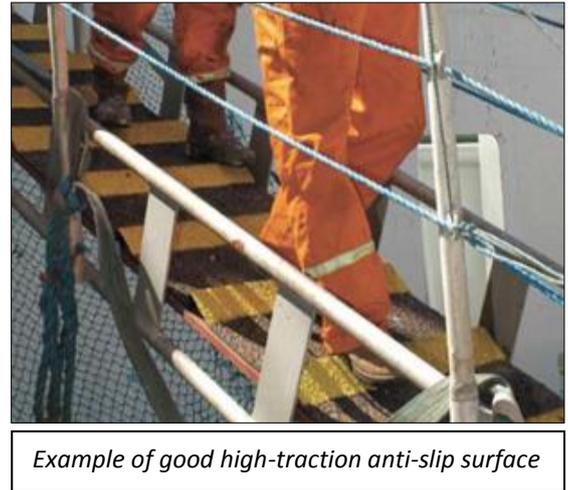
4. Poorly placed/rigged safety nets and low grip surfaces are another frequently sighted problem.

10. A safety net should be mounted where a person may fall from the gangway, ship's deck or quayside. The aim of the safety net is to minimize the risk of injury arising from falling between the ship and the quay or falling on to the quay or deck and as far as reasonably practicable the whole length of the gangway should be covered. Safety nets should be securely rigged, with use being made of securing points on the quayside where appropriate.
